NONCIRCULAR CFRP BICYCLE'S CHAINRING. PART I: STATIC AND LOW-VELOCITY IMPACT ANALYSIS

The paper presents an experimental analysis to determine the teeth failure of noncircular composite chainring. A noncircular carbon/epoxy chainring with a specific stacking of 11 plies is studied. In a first step, a quasi-static tensile test is realized on the chain and on the chainring to determine their strength. As the damage of composites is a major concern, as a second step the low-velocity/low-energy impact drop tests are performed. Five levels of impact energy are investigated in order to study the energy effect on the teeth damage, and the damage localization is analyzed using C-Scan. Quasi-static results show that the metallic chain fails first. Experimental impact results reveal that teeth damage is presented only for an impact higher than 1.6 J. Finally, the total teeth failure appears for an energy close to 2.5 J.

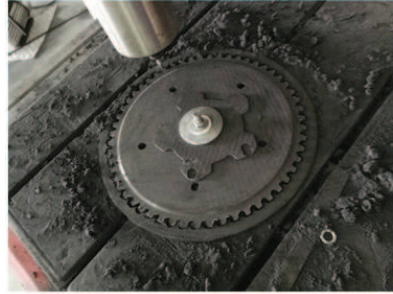
FIG. 4: Teeth cutting process on typical carbon/epoxy chainring

The chain is made from steel (Table 2), while carbon 2/2 twill woven/epoxy is used for the chainring (Table 3). The chainring consists of 11 plies of 0.23 mm each with the following stacking: [30/60/0/60/30/0/30/60/0/60/30], given a chainring thickness of 2.53 mm after manufacturing. The chainring is manufactured through oven under 1 bar of pressure with a curing cycle of 80°C for 1 h followed by a hold step at 120°C during 3 h. Finally, teeth are cut thanks to a CNC with a carbide end mills — style 4 Flute (\varnothing 4 mm) and with a rotational speed of 15,000 rpm and a cutting speed of 5 mm/min (Fig. 4).
